DEGRADATION OF COATING ALLOYS  
IN SIMULATED MARINE ENVIRONMENTS

R.H. Barkalow and F.S. Pettit  
Pratt & Whitney Aircraft Division  
United Technologies Corporation  
400 Main Street  
East Hartford, Connecticut 06108

15 June 1978

Final Report: 1 March 1976 to 1 March 1978

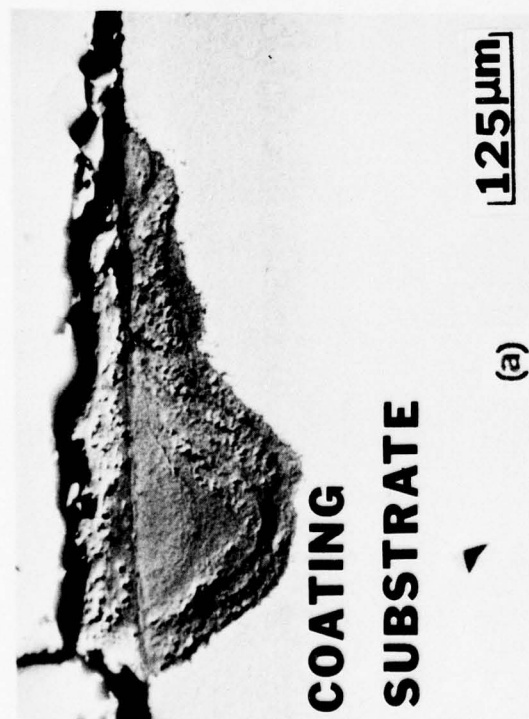
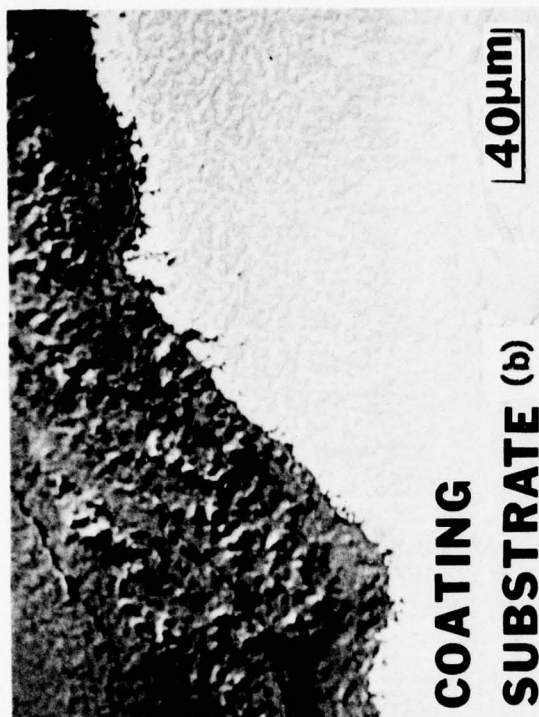
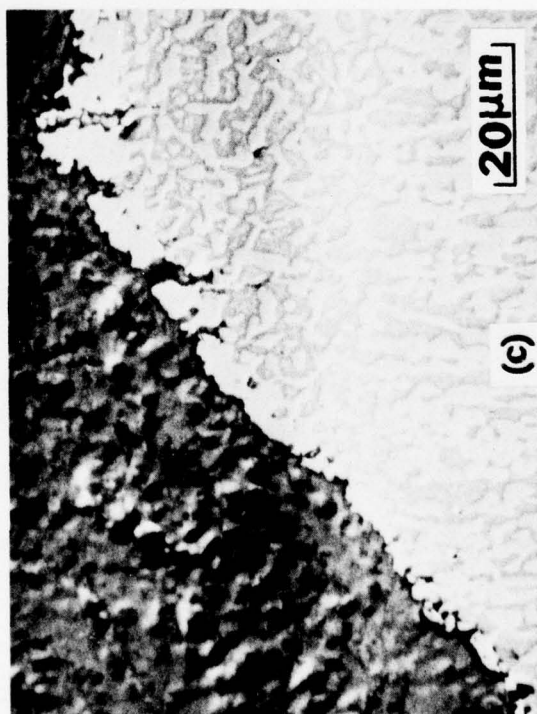
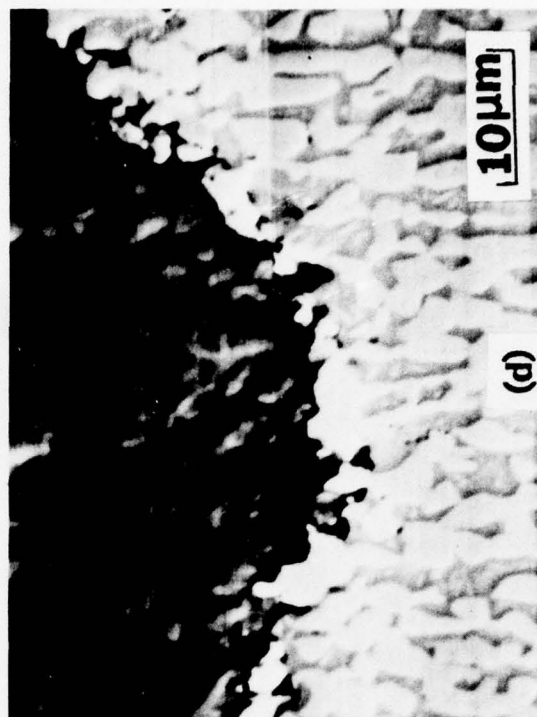
Figures 1 - 3 include photomicrographs and X-ray area scans at various magnifications which show the characteristic form of the localized nodular attack believed to be primarily responsible for degradation and failure of the coating on both the blades and the vanes. The information presented in this series of photographs is intended to illustrate the following features which are of significance in deducing the mechanism of attack\* and in comparing service degradation with that produced in laboratory specimens;

Except for the areas of highly localized nodular attack, the microstructure of the coating and the coating/substrate interdiffusion zones illustrated in Figure 1 are indistinguishable from those of as-processed hardware. This observation restricts the thermal history of the affected zone to a range of time-at-temperature which did not cause significant dilution of the coating chemistry by long range diffusion. Thus the scale/metal interface advanced at a rate which is rapid compared to diffusion of Co, Cr, and Al in the coating and the propagation mechanism did not involve long range diffusion of these elements.

The presence or absence of a diffusion-affected zone at the scale/metal interface is of critical importance with respect to the hot corrosion mechanism. As apparent in Figure 1, however, the microstructure of the attack front is not uniform. Some areas are characterized by a thin but unequivocally recognizable  $\beta$ -depleted zone (e.g. the right half of Figs. 1b, 1c); others show a type of in-situ attack of the  $\beta$ -CoAl, leaving non-continuous areas of  $\alpha$ -Co in contact with the scale (Figure 1d).

Figure 1. Typical coating protrusion in CoCrAlY-coated (IM 6250; 18-24%Cr, 11-13%Al, 0.1-0.5%Y) IN 792 first stage turbine blade operated 4801 hours in Asiafreighter engine.

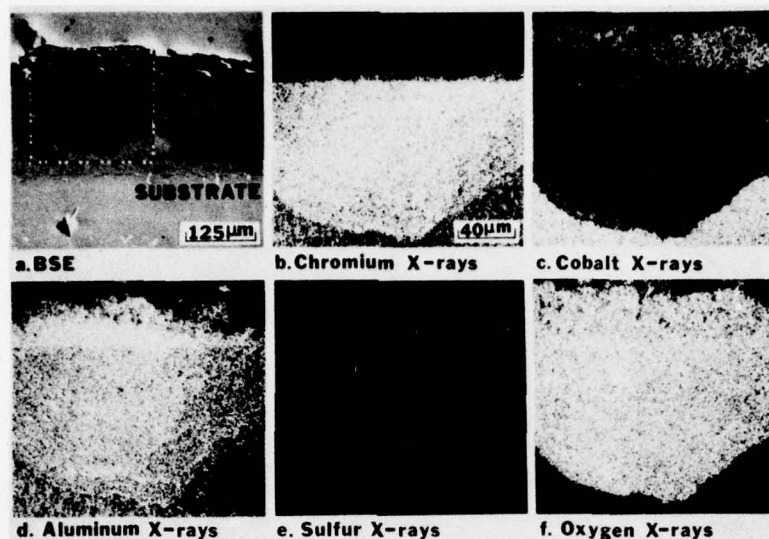
Figure 2 presents low magnification x-ray area scans showing the entire depth of a protrusion and oxide mound. It is evident that the volume of the protrusion is primarily  $\text{Cr}_2\text{O}_3$  with relatively little  $\text{CoO}$ ; conversely the oxide mound contains  $\text{CoO}$  but very little  $\text{Cr}_2\text{O}_3$  (Figs. 2b, 2c). Aluminum oxide is present in both the protrusion and the mound; aluminum enrichment delineates the attack front in some areas and several lines of Al concentration in the protrusion presumably mark prior locations of the scale/metal interface (Fig. 2d). Sulfur appears to be concentrated at the attack front, although the entire boundary of the protrusion is not uniformly well defined in X-ray images (Figure 2e).

Figure 2. Low magnification X-ray images showing composition of oxides in coating protrusion and overlying mound. Box in (a) is area of X-ray scans.

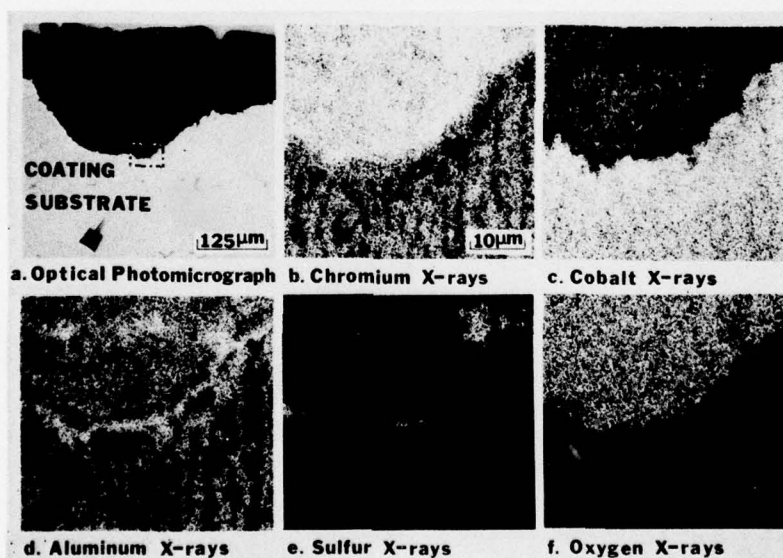
The distribution of Cr, Co, Al, S, and O at the scale/metal interface is shown by the high magnification X-ray images in Figure 3 (the area ill-

ustrated is approximately that of Fig. 1d). The scan for chromium (Fig. 3b) suggests that the  $\alpha$ -Co phase immediately in contact with the scale may be depleted in Cr, but there is otherwise no indication of a Cr gradient in the coating. The scale/metal interface is sharply defined by Co depletion in the protrusion (Fig. 3c) as well as by Al enrichment (Fig. 3d); however, the entire periphery of the protrusion is not marked by Al enrichment as prominent as that in the area of Fig. 3d. Sulphur is likewise non-uniformly concentrated in the scale at the attack front (Fig. 3e), apparently in areas also rich in aluminum. Oxygen is present up to the scale/metal interface (Figure 3f).

Figure 3. High magnification X-ray images showing element distribution in attack front at bottom of coating protrusion. Area of X-ray scans (box in 3a) is approximately that of Fig. 1d.

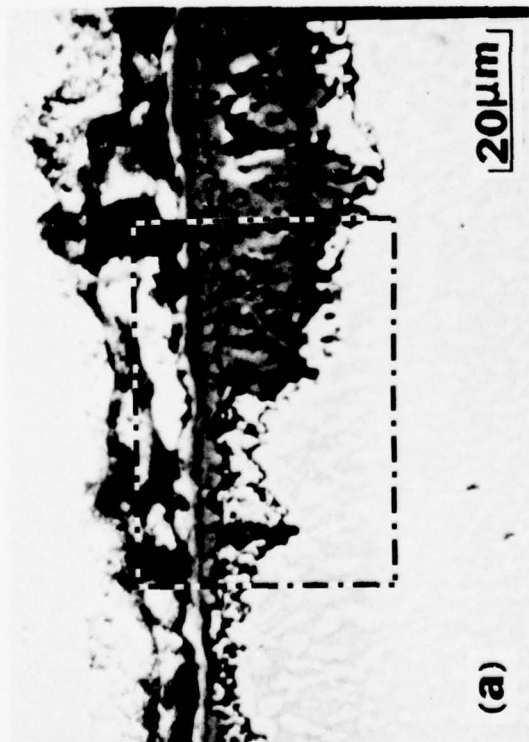
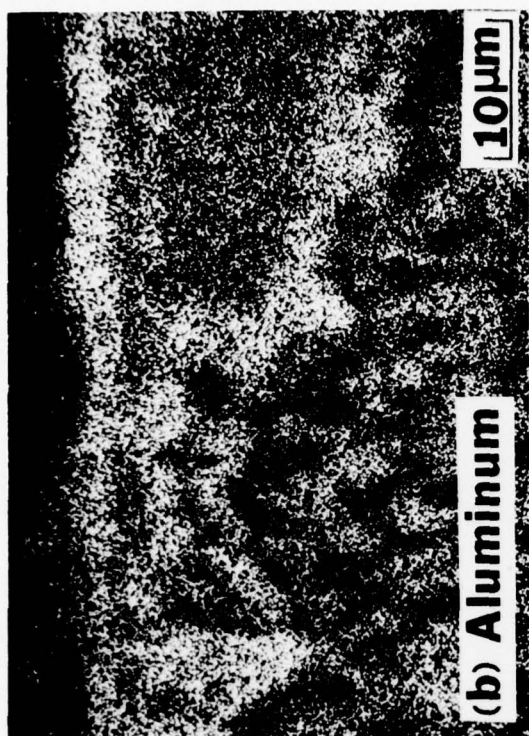
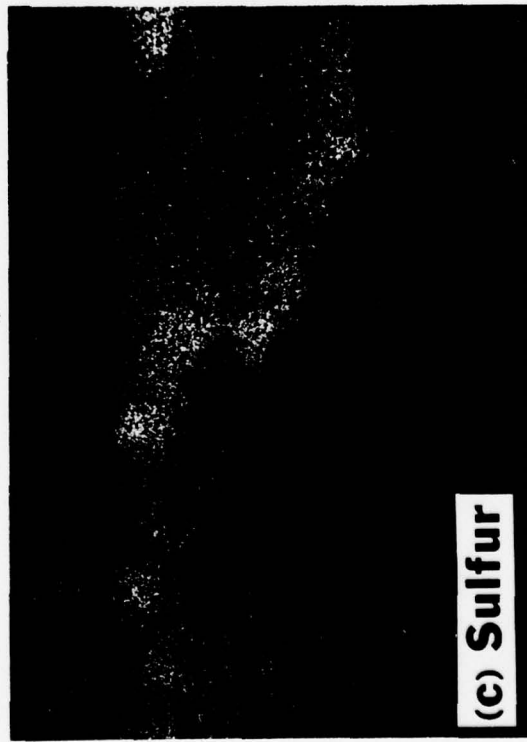
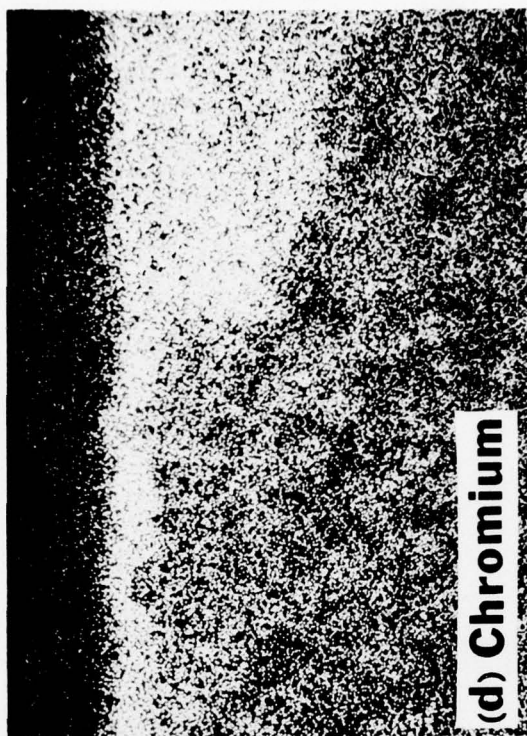
A second morphology of the attack front observed in several areas of the blades was the type of surface degradation and shallow pit formation illustrated in Figure 4. Characteristic features were an external scale of  $\text{Al}_2\text{O}_3$  (Fig. 4a, 4b) and a prominent  $\beta$ -denuded zone at the surface and around the pit. The denuded zone was laced with a network of corrosion product, and sulfur was readily detectable on the surface and around the periphery of the pit (Fig. 4c).

Figure 4. Surface degradation and shallow pitting characteristic of some areas of Asiafreighter blades.

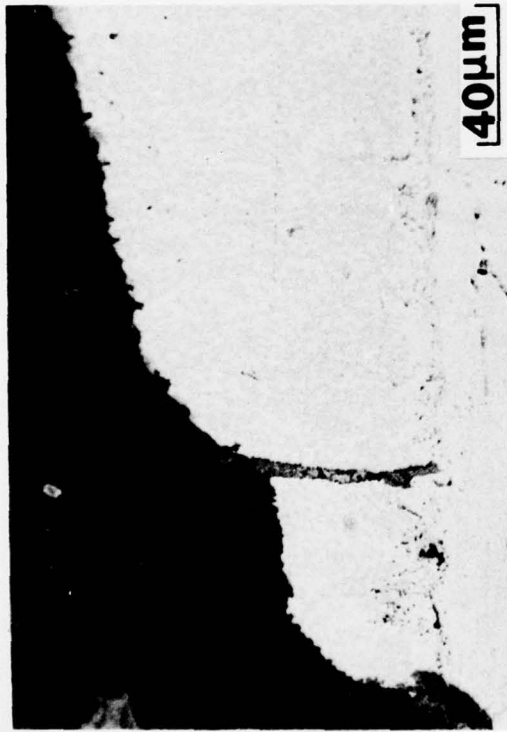
One of the CoCrAlY-coated vanes on which  $\text{Na}_2\text{Co}(\text{SO}_4)_2$  had been detected was prepared for metallographic examination by dry cutting and dry polishing; optical and SEM photomicrographs of typical features near the leading edge are presented in Figure 7. The coating on the leading edge itself was completely consumed and the substrate was attacked; however, the coating microstructure was unaffected up to the attack front and there was no diffusion zone at the scale/metal interface (Figure 7a). A thin  $\beta$ -denuded zone was present in other regions of the attack front (arrow in Fig. 7b); Fig. 7b also shows the Co-containing sulfate salt on the surface of the vane. High magnification study of a shallow but well developed protrusion showed continuous  $\alpha$ -Co in contact with the scale, although the thickness and morphology of the  $\alpha$  layer suggested preferential consumption of  $\beta$  (leaving  $\alpha$ -Co at the attack front) rather than formation of additional areas of  $\alpha$  via a diffusion-controlled transformation (Figure 7c).

7a. Penetrated coating at leading edge

Figure 7. Microstructure near failed leading edge of PWA 68-coated Mar-M509 first stage vane operated 2770 hours in Asiafreighter engine. Area of 7c is shown in X-ray images of Figure 8.

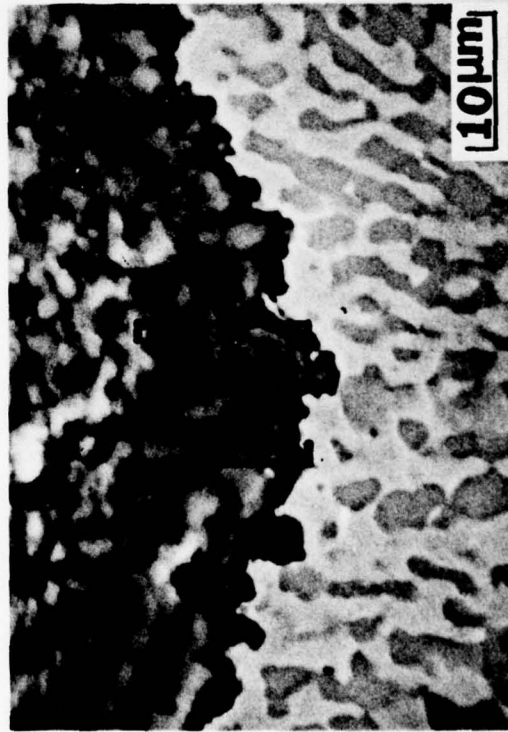
7c. Scale/metal interface; boxed area in 7b

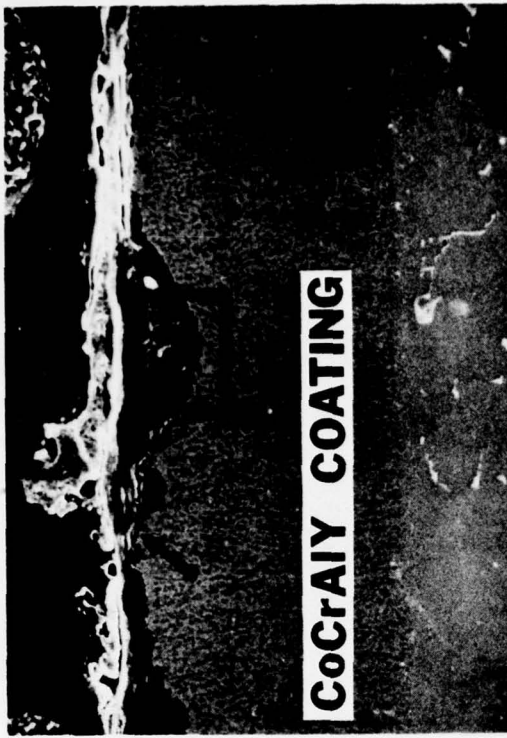
7b. Typical nodular attack and surface corrosion products near leading edge

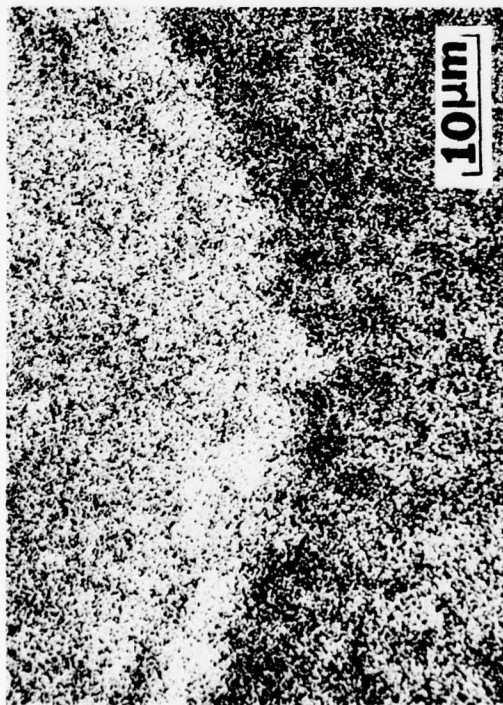
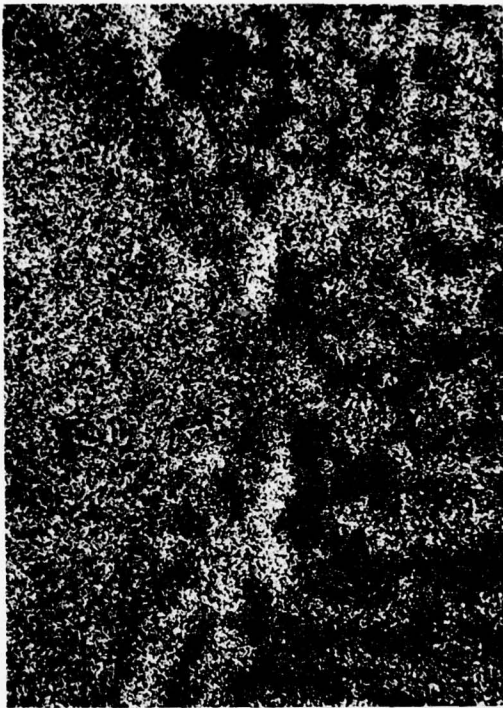
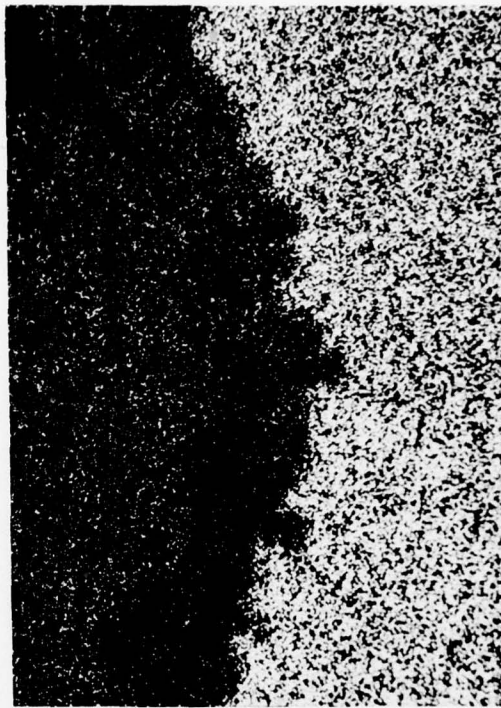
Figure 8. Distribution of metallic elements and sulfur at bottom of coating protrusion in Asiafreighter vane. Sample was prepared by dry cutting and polishing with kerosene lubricant.

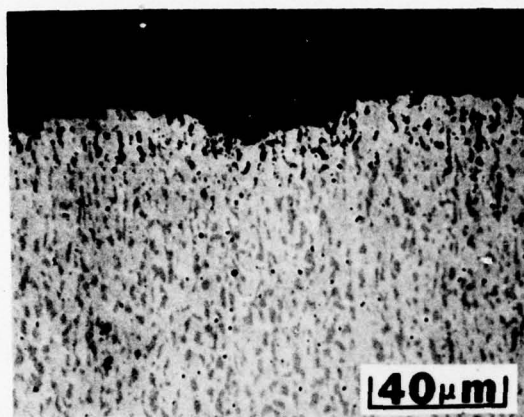
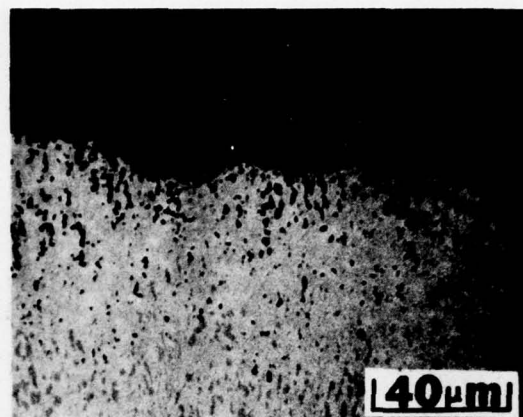
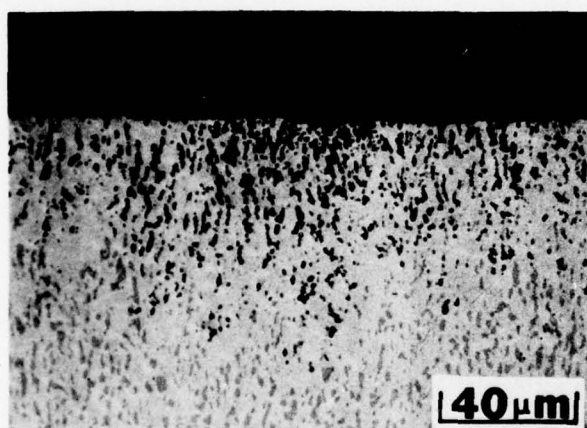
Figure 9. Surface microstructure of Co-25Cr-6Al-0.5Y after cyclic hot corrosion testing for 500 hours at 649°C (1200°F). Salt deposits were (a) 100%  $\text{Na}_2\text{SO}_4$ , (b)  $\text{Na}_2\text{SO}_4$  - 1% NaCl, and (c)  $\text{Na}_2\text{SO}_4$  - 10% NaCl.

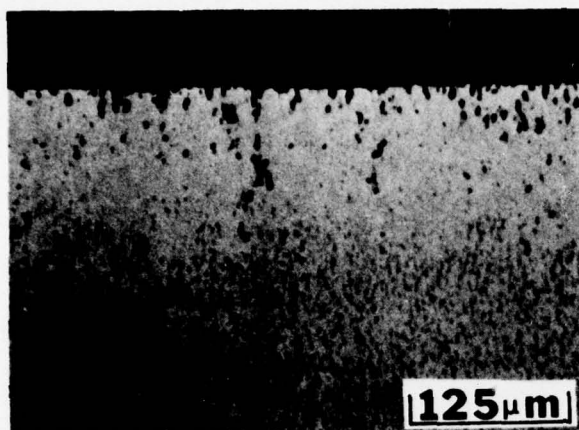
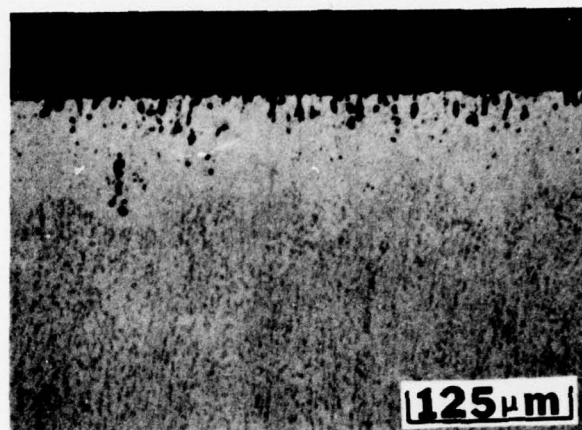
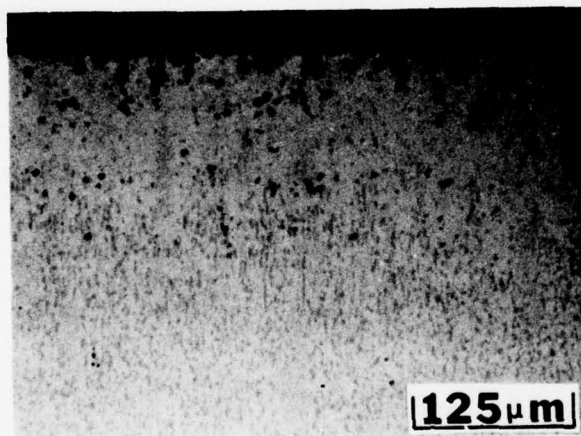
Figure 10. Surface microstructure of Co-25Cr-6Al-0.5Y after cyclic hot corrosion testing for 500 hours at 899°C (1650°F). Material, test conditions, and salt deposits are the same as those of Fig. 9 except for the higher temperature.

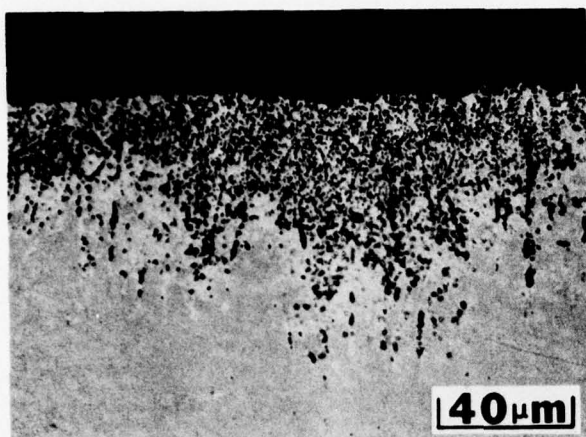
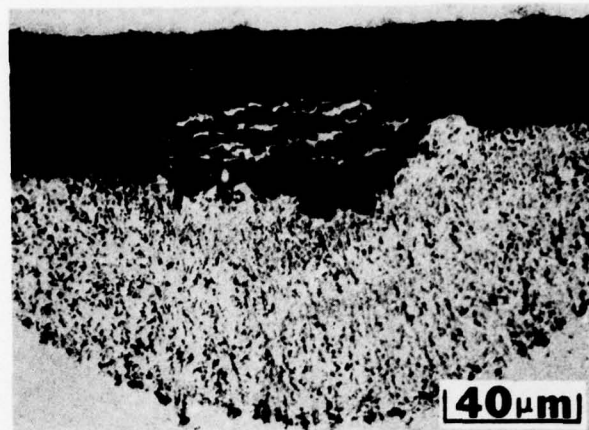
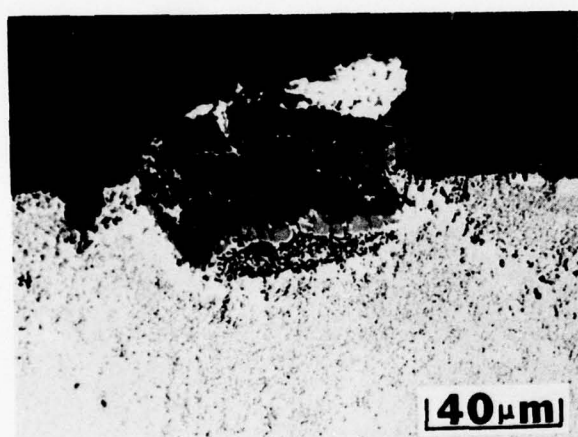
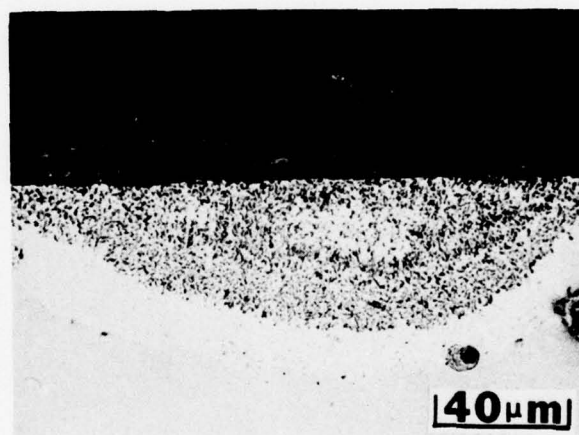
Figure 11. Degradation of state-of-the-art CoCrAlY (PWA 68), NiCrAlY (PWA 267), and NiCoCrAlY (PWA 270) coatings (a, b, and c respectively) and an experimental high-chromium CoCrAlY alloy after cyclic hot corrosion testing for 500 hours at 649°C (1200°F) with  $\text{Na}_2\text{SO}_4$  - 10% NaCl.

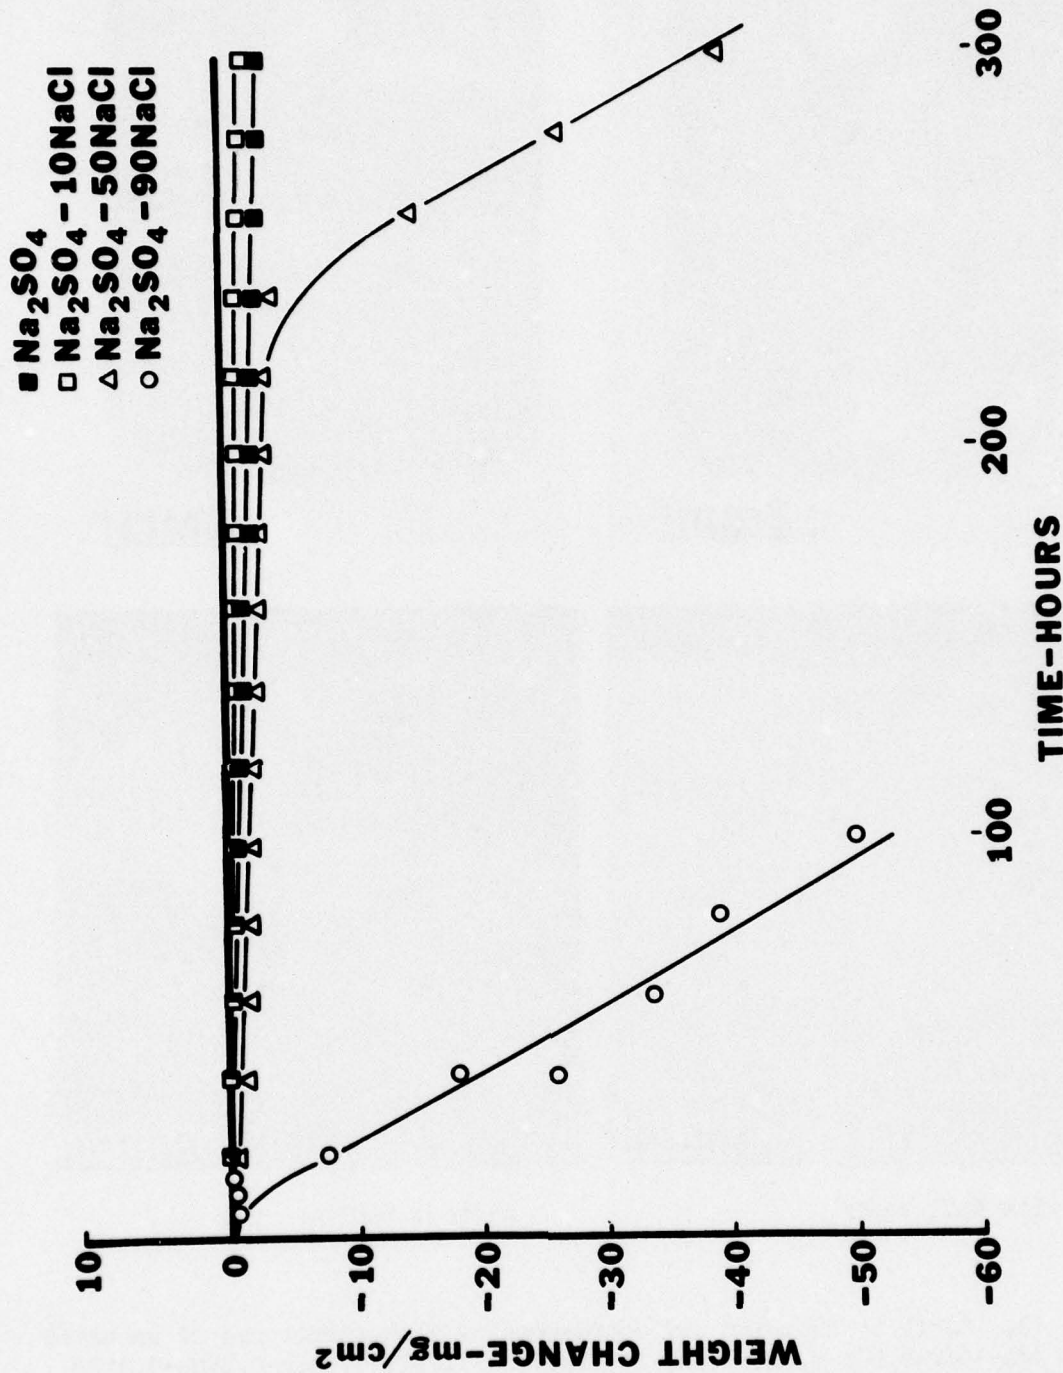
Figure 13. Weight change vs. time data for 899°C (1650°F) cyclic hot corrosion of Co-25Cr-6Al-0.5Y with deposits of sulfate and sulfate-chloride salts. Data show increasing severity of attack (as indicated by decreasing time to start of large weight losses) with increasing chloride content of the deposit.

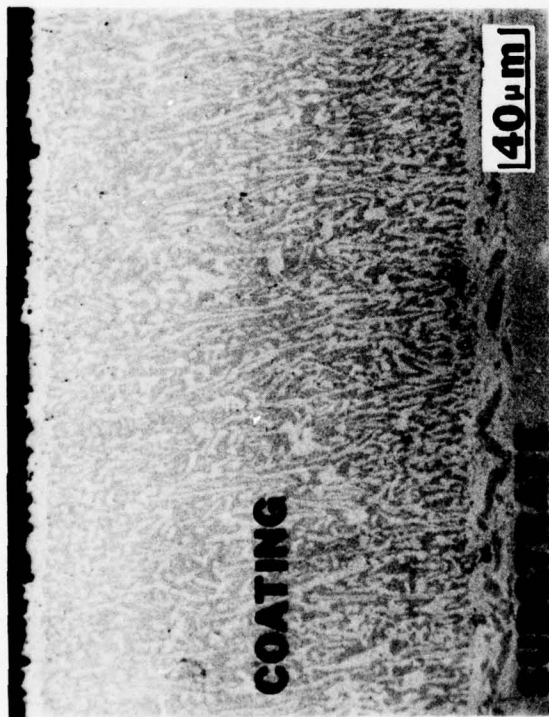
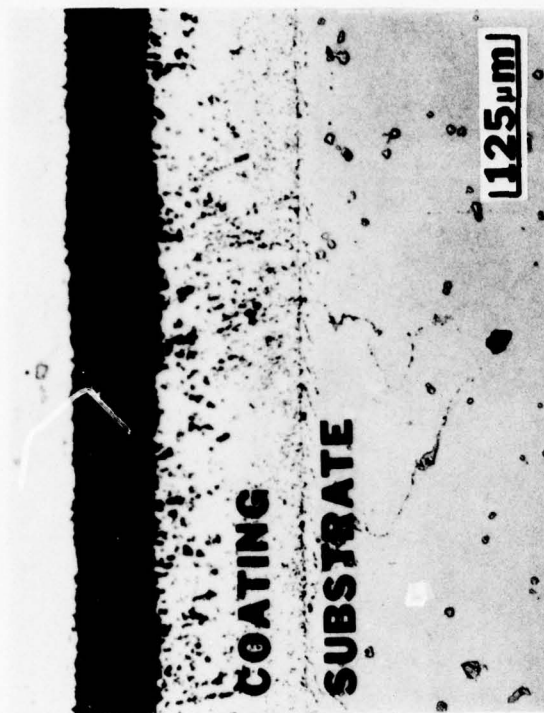
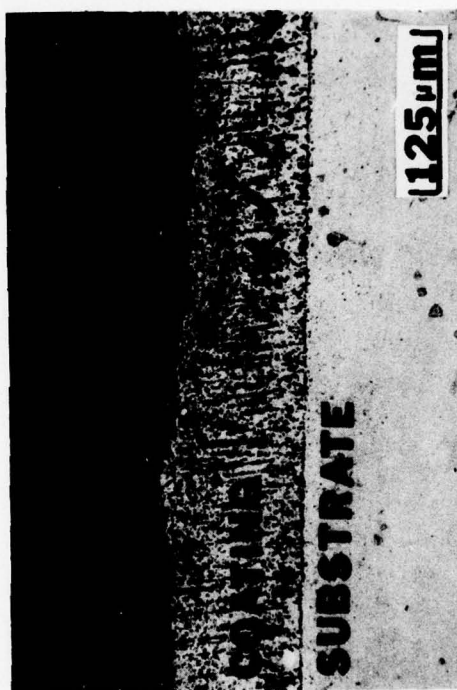
Figure 14. Effect of chloride-containing deposits on degradation of CoCrAlY-coated IN 738 in 899°C cyclic hot corrosion test: (a) 500 hours with  $\text{Na}_2\text{SO}_4$ , (b) 500 hours with  $\text{Na}_2\text{SO}_4$  - 5% NaCl, (c) 40 hours with  $\text{Na}_2\text{SO}_4$  - 90% NaCl.

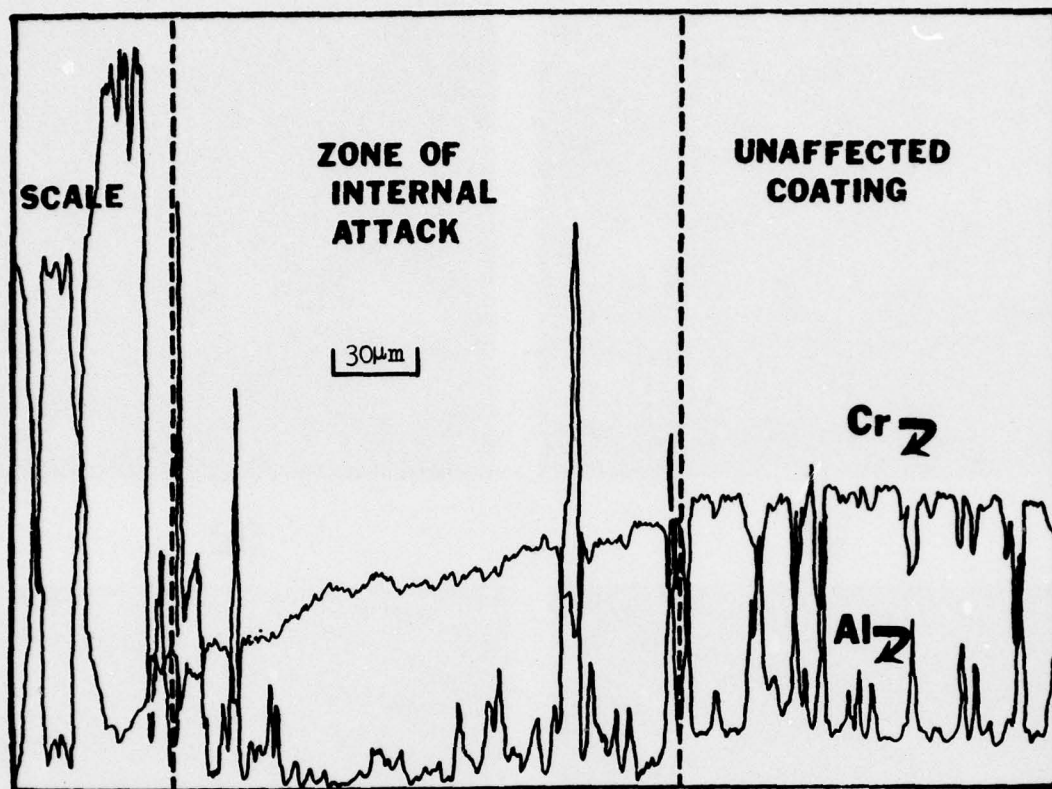
Figure 17. Semiquantitative line scans for Cr and Al in the specimen of Figs. 15 and 16. Peaks and valleys in unaffected material reflect different Cr and Al content of the  $\alpha$ -Co and  $\beta$ -CoAl phases but a uniform average composition. Zone of internal attack includes Al-rich phases, but Cr content decreases smoothly across the zone.

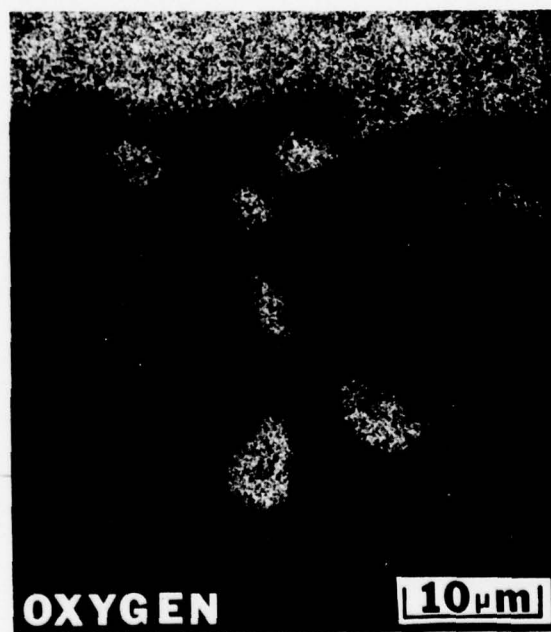
(d)

Figure 18. Back scattered electron (a) and X-ray images of CoCrAlY specimen exposed 20 hours at 899°C in crucible hot corrosion test with  $\text{Na}_2\text{SO}_4$  - 90% NaCl salt. Note cavities filled with nonmetallic reaction product containing Al, Cl, and O.

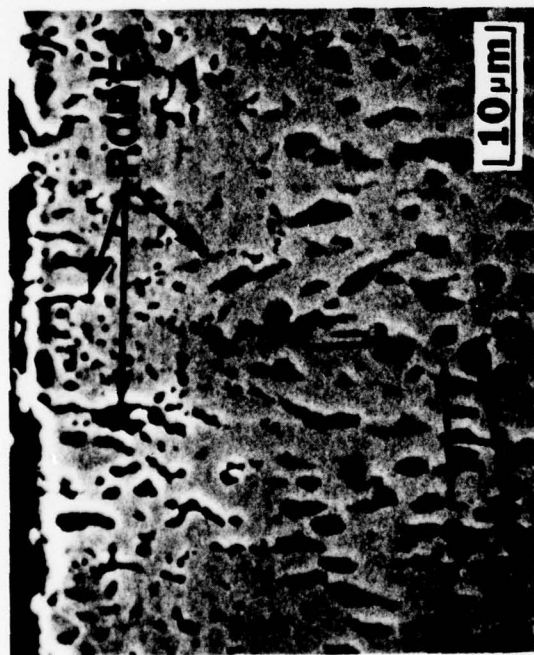
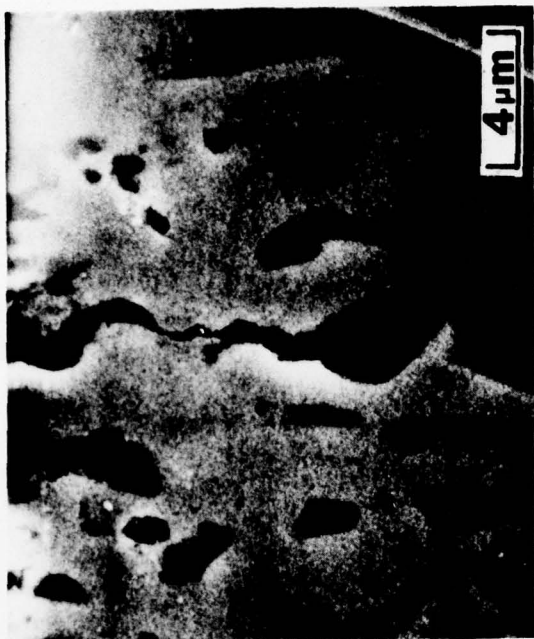
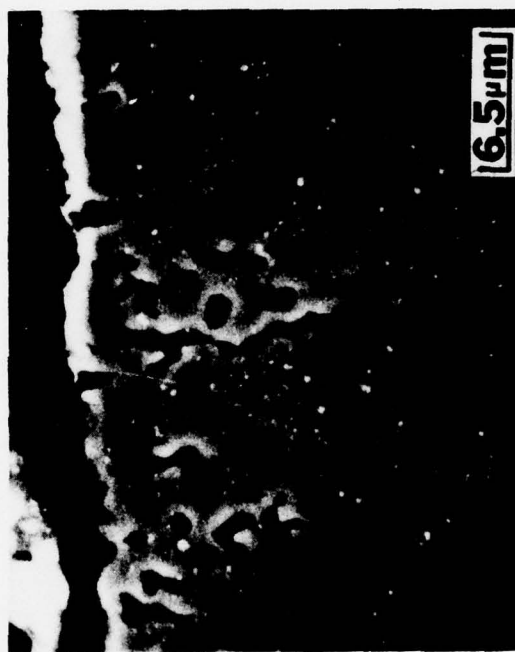
\*Features such as that in Fig. 21b were difficult to locate on polished specimens. However, the fractured sample illustrated in Fig. 19 would suggest that continuous channels to the surface are common in the three-dimensional geometry of pores and  $\beta$  particles in the  $\alpha$  matrix.

Figure 21. Scanning electron micrographs of polished section through specimen of Fig. 20. Note that large pores are similar but not identical in shape and distribution to those of the  $\beta$ -CoAl phase in the unaffected microstructure.

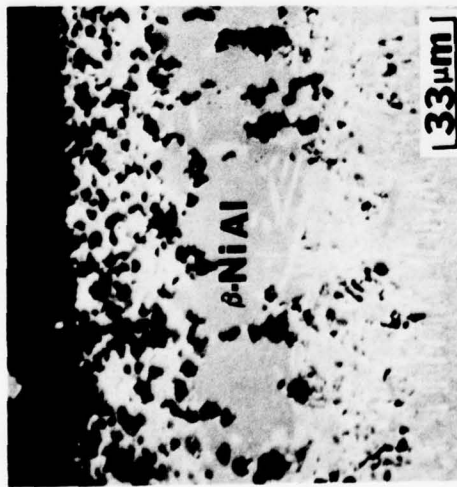
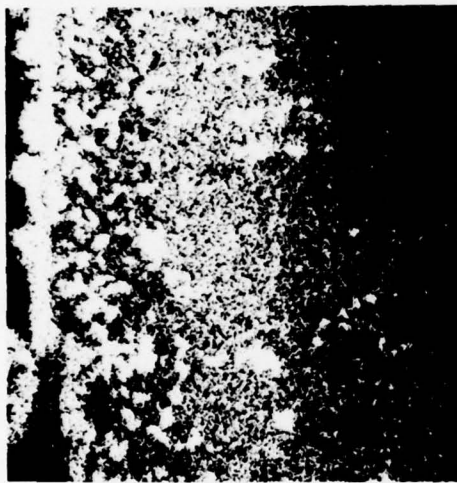
Figure 29 includes x-ray area scans of the degraded coating for Al, Ti, Cr, O, and S. It is evident that the external scale is  $\text{Al}_2\text{O}_3$ ; this scale is much thicker than that which would have formed in absence of the salt deposit and is spalling off in numerous areas. Oxides found within the coating are rich in Al and Ti, and chromium sulfides are also readily apparent (Figures 29b-29f). Such development of internal oxides in a coating still rich in aluminum (i.e. still containing  $\beta$ -NiAl) indicates the liquid salt must be de-alloying localized regions of aluminum.

Figure 29. Typical microstructure of PWA 273 coating after 500 hours cyclic hot corrosion testing at 899°C. Note retention of substantial amounts of  $\beta$ -NiAl phase, as shown in BSE and Al X-ray images.

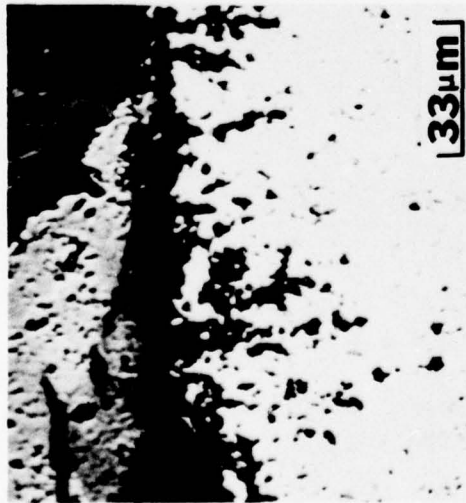
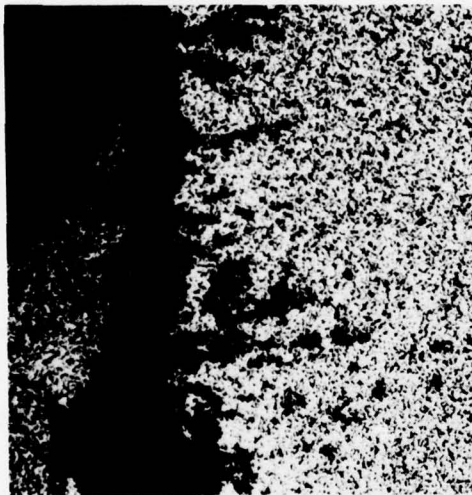
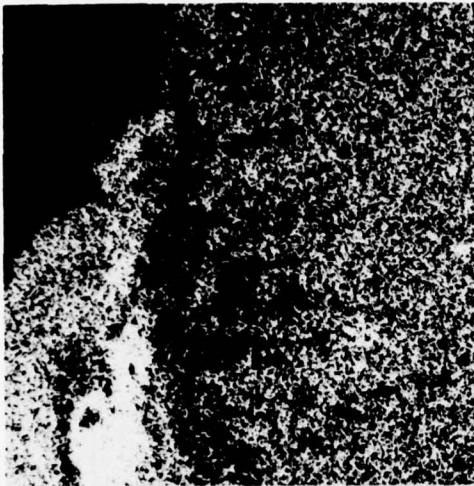
Edge failure and cut-edge consumption of the coating are illustrated in Figure 31a and protrusions of the type in Figure 31b were readily observable in both specimens. As on the FWA 273 coating, X-ray area scans (Figure 32) showed a relatively thick external scale of  $\text{Al}_2\text{O}_3$ . At locations where coating protrusions were developing, stringers of  $\text{Al}_2\text{O}_3$  extended into the coating and the microstructure was depleted of  $\beta$ -CoAl. Chromium sulfide precipitates were evident in the Al-depleted areas. The mound of scale over the protrusion was composed of an outer zone of cobalt chromate spinel and well defined layers of  $\text{Cr}_2\text{O}_3$  and  $\text{Al}_2\text{O}_3$ .

Figure 32. Scanning electron micrographs of coating protrusion in PWA 68, showing composition of oxide mound and penetration of oxygen and sulfur.

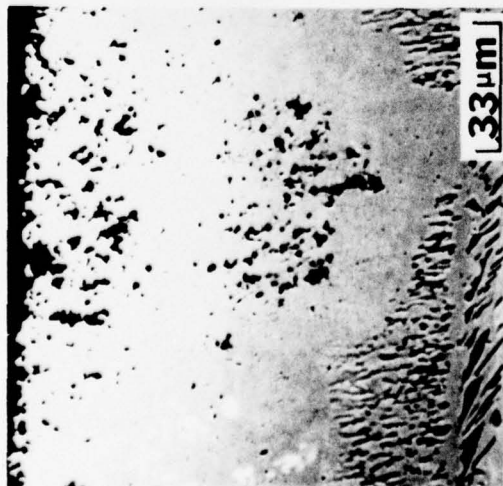
Performance of the CoCrAlY coating was significantly improved by the platinum overlayer; both samples were exposed for 500 hours, although edge distress was evident in some locations after 300 hours. In spite of oxide mounds on the surface, metallographic examination showed no penetration of the coating except at edges of the coupons. Development of coating protrusions appeared to involve the same mechanism of aluminum dealloying and internal oxidation as in FWA 68 but the coating lifetime was extended by the necessity of first penetrating the platinum overlayer (Figure 34). Pene-

Figure 34. Scanning electron micrographs of coating protrusion in PWA 68 + Pt overlay coating. Structure and element distribution appear similar to those of PWA 68 (Fig. 32) except for the Pt-containing phases.

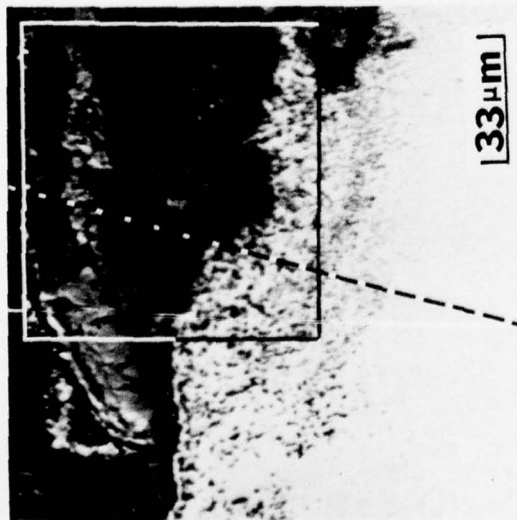
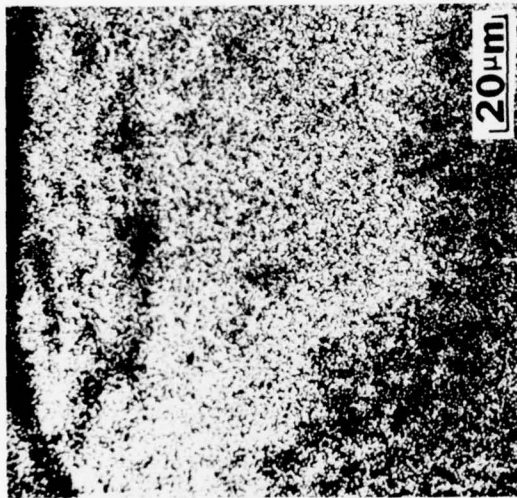
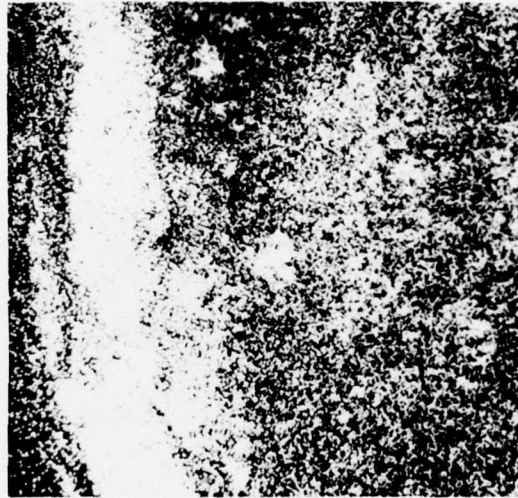
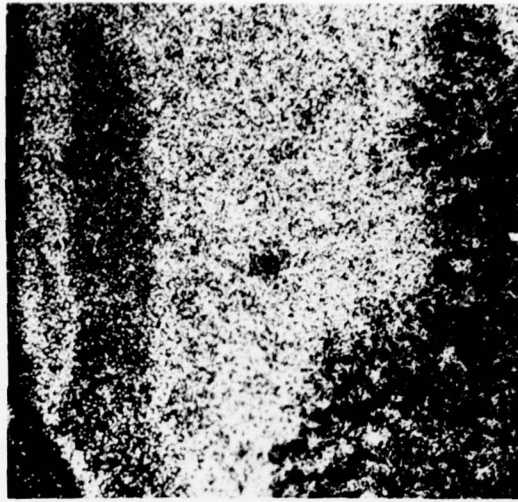
Figure 41 includes a back scattered electron image and X-ray area scans for oxygen, sulfur, and the major coating constituents. These photos, a line scan along the path shown in Figure 41a, and KEVEX spectra of selected points indicate the affected area consists of a front of  $\text{Al}_2\text{O}_3$  particles, a zone of  $\text{Al}_2\text{O}_3$  and  $\text{CrS}$  particles, and a mixture of Cr- and Al-rich oxides forming the volume of the protrusion. There is relatively little  $\text{CoO}$  (Figure 41d) except for the outer layer of the oxide mound. The line scan showed that the matrix solid solution in the zones of  $\text{CrS}$  and  $\text{Al}_2\text{O}_3$  precipitation was almost completely dealloyed of aluminum and a gradient of Cr content existed through this zone. This shows that the chloride-containing melt is capable of dealloying the coating of chromium, as well as aluminum, although the aluminum is apparently attacked first and its concentration must be reduced to a low level before chromium is preferentially removed from the alloy.

Figure 41. Coating protrusion in PWA 68 after cyclic hot corrosion testing for 780 hours at 649°C with  $\text{Na}_2\text{SO}_4$  - 50%NaCl. Box in 41a is area of X-ray images; dotted line is path of line scan discussed in text.

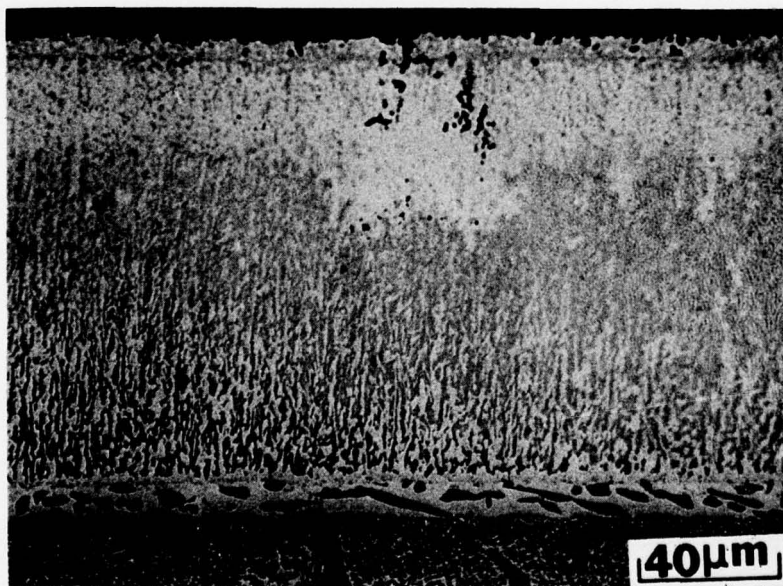
samples developed a small greenish spot at 380 hours but it appeared to be very shallow and did not grow with continued exposure. Metallographic examination of this sample showed only superficial oxidation and possibly development of very small oxide stringers (arrow in Fig. 42a). After 2000 hours the coating on the duplicate specimen was still protective, although dealloying and internal oxidation could be observed in some areas (Figure 42b).

42b. Microstructure of PWA 68 + Pt after 2000 hours at 649°C

Figure 42. Minimal degradation of microstructure of PWA 68 + Pt coating was observed in the 649°C cyclic hot corrosion test with  $\text{Na}_2\text{SO}_4$  - 50% NaCl.

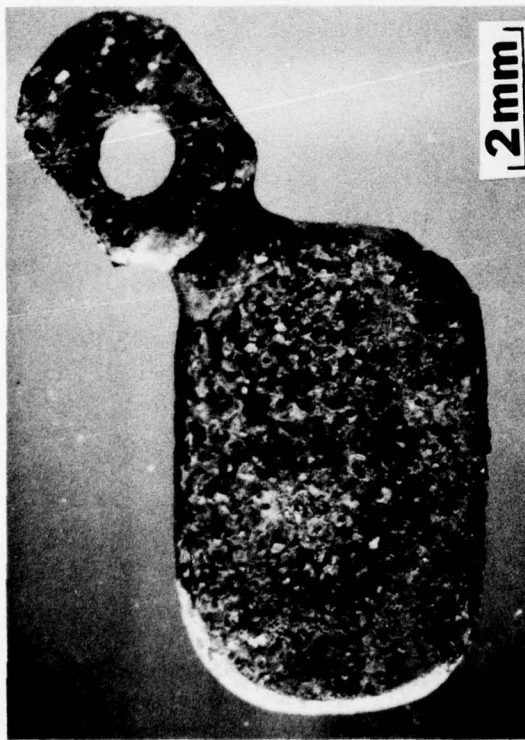
43a. Surface condition

Figure 43. Surface condition and microstructure of PWA 73 diffusion aluminide coating after 120 hours in 899°C cyclic hot corrosion test with  $\text{Na}_2\text{SO}_4$  - 50% NaCl. Test was terminated due to general surface degradation and corner failure.

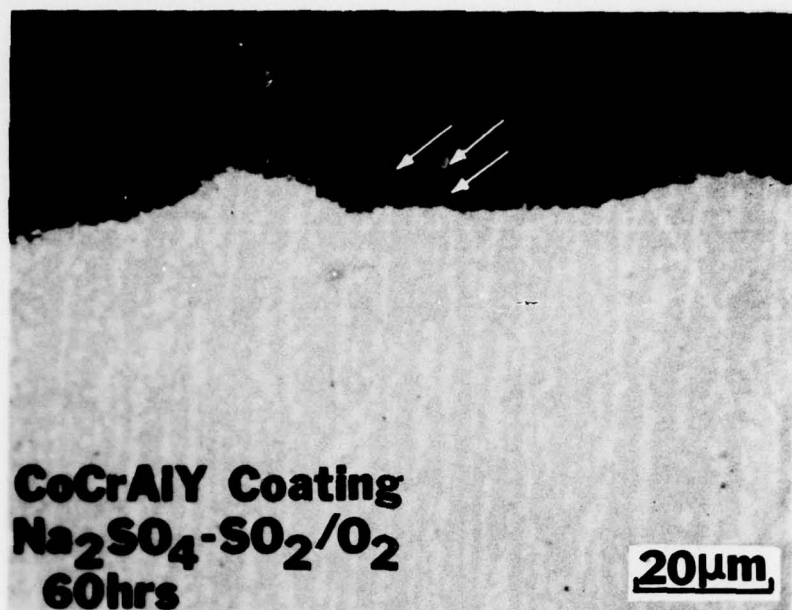
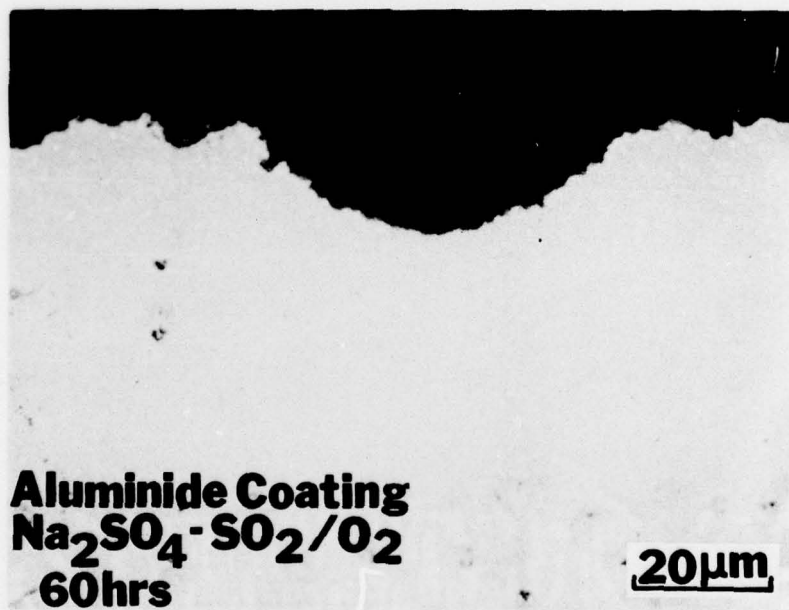
PWA 68 CoCrAlY and PWA 273 diffusion aluminide were exposed 60 hours to the test conditions described in the preceding paragraph. Visual inspection indicated significant degradation, although subsequent metallography showed less material consumption than inferred from the surface condition (Figure 67).

Figure 67. Attack of PWA 68 CoCrAlY and PWA 273 diffusion aluminide at 649°C produced by 1 mg/cm<sup>2</sup> Na<sub>2</sub>SO<sub>4</sub> salt deposit and 0.04 atm SO<sub>2</sub> pressure (from equilibration of mixture of flowing SO<sub>2</sub>:O<sub>2</sub> at the test temperature). White arrows mark features which appear to be small metallic globules sometimes observed in the inner layer of the scale.
